Pentium® II Processor Specification Update

Release Date: July 1998

Order Number: 243337-016

The Pentium® II processor may contain design defects or errors known as errata which may cause the product to deviate from published specifications. Current characterized errata are documented in this Specification Update.

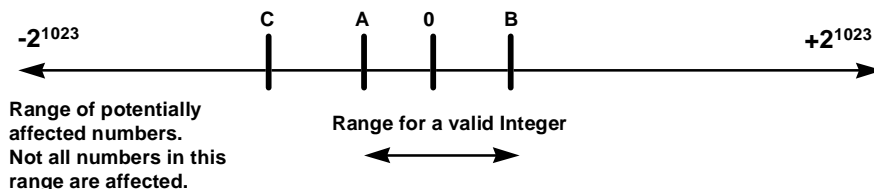
IMPLICATION: Erroneous operation results when the operand is so large that it will not fit into the target data size. The operands affected by this erratum are significantly outside (by a factor of 3X) the range that can be, correctly, converted to an integer value. The figure below and corresponding table identifies the normal range of integer numbers (between A and B) and the starting point of the operands affected by this erratum. Discrete failing operands will be present in the range between point C and the maximum negative number that can be represented by the processor (-2^{1023} in double precision format). Note 2 below gives a qualitative description of the nature of the discrete failing values. Software that does not rely on the Invalid Operation exception flag being set and signaled by either an exception OR by software polling is not impacted by this erratum.

16-bit Operation	A	B	C
	-32,768.0	+32,767.0	< -98304.0
32-bit Operation	A	B	C
	-2,147,483,648.0	+2,147,483,647.0	< -6,442,450,944.0

WORKAROUND: Any of two software workarounds will avoid occurrence of this erratum:

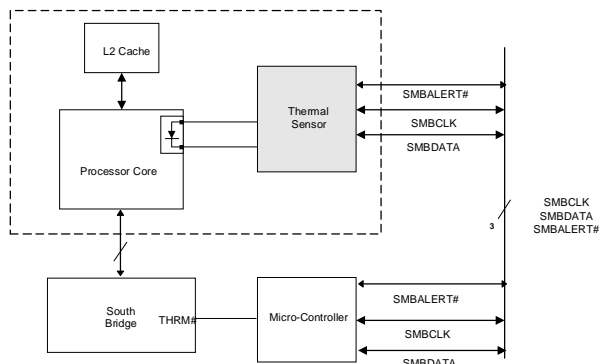
Figure 1. An Example of Micro-controller Driven Thermal Management

PROBLEM: The Mobile Pentium II processor and the Pentium II processor Mobile Module have a thermal sensor that monitors the processor core's temperature. Please note that desktop systems could have a similar thermal

device. The thermal sensor asserts SMBALERT# if the processor temperature exceeds the temperature limits set in the Alarm Threshold Registers (T_{HIGH} , T_{LOW}). It also sets the corresponding Status Register bits to identify the cause of the interrupt. Figure 1 gives one example of the how the SMBALERT# signal could be used in a system.

Under the conditions described below, the thermal sensor incorrectly generates the SMBALERT# interrupt. *All* of the following conditions must be met to trigger a false interrupt:
